TO: Gary Miller, Remedial Project Manager
U.S. Environmental Protection Agency Region VI

FROM: Barry Forsythe, Ph.D., Technical Liaison
U.S. Fish & Wildlife Service

DATE: 13 June 2005

RE: Site visit trip report, Gulfco Marine Maintenance Site

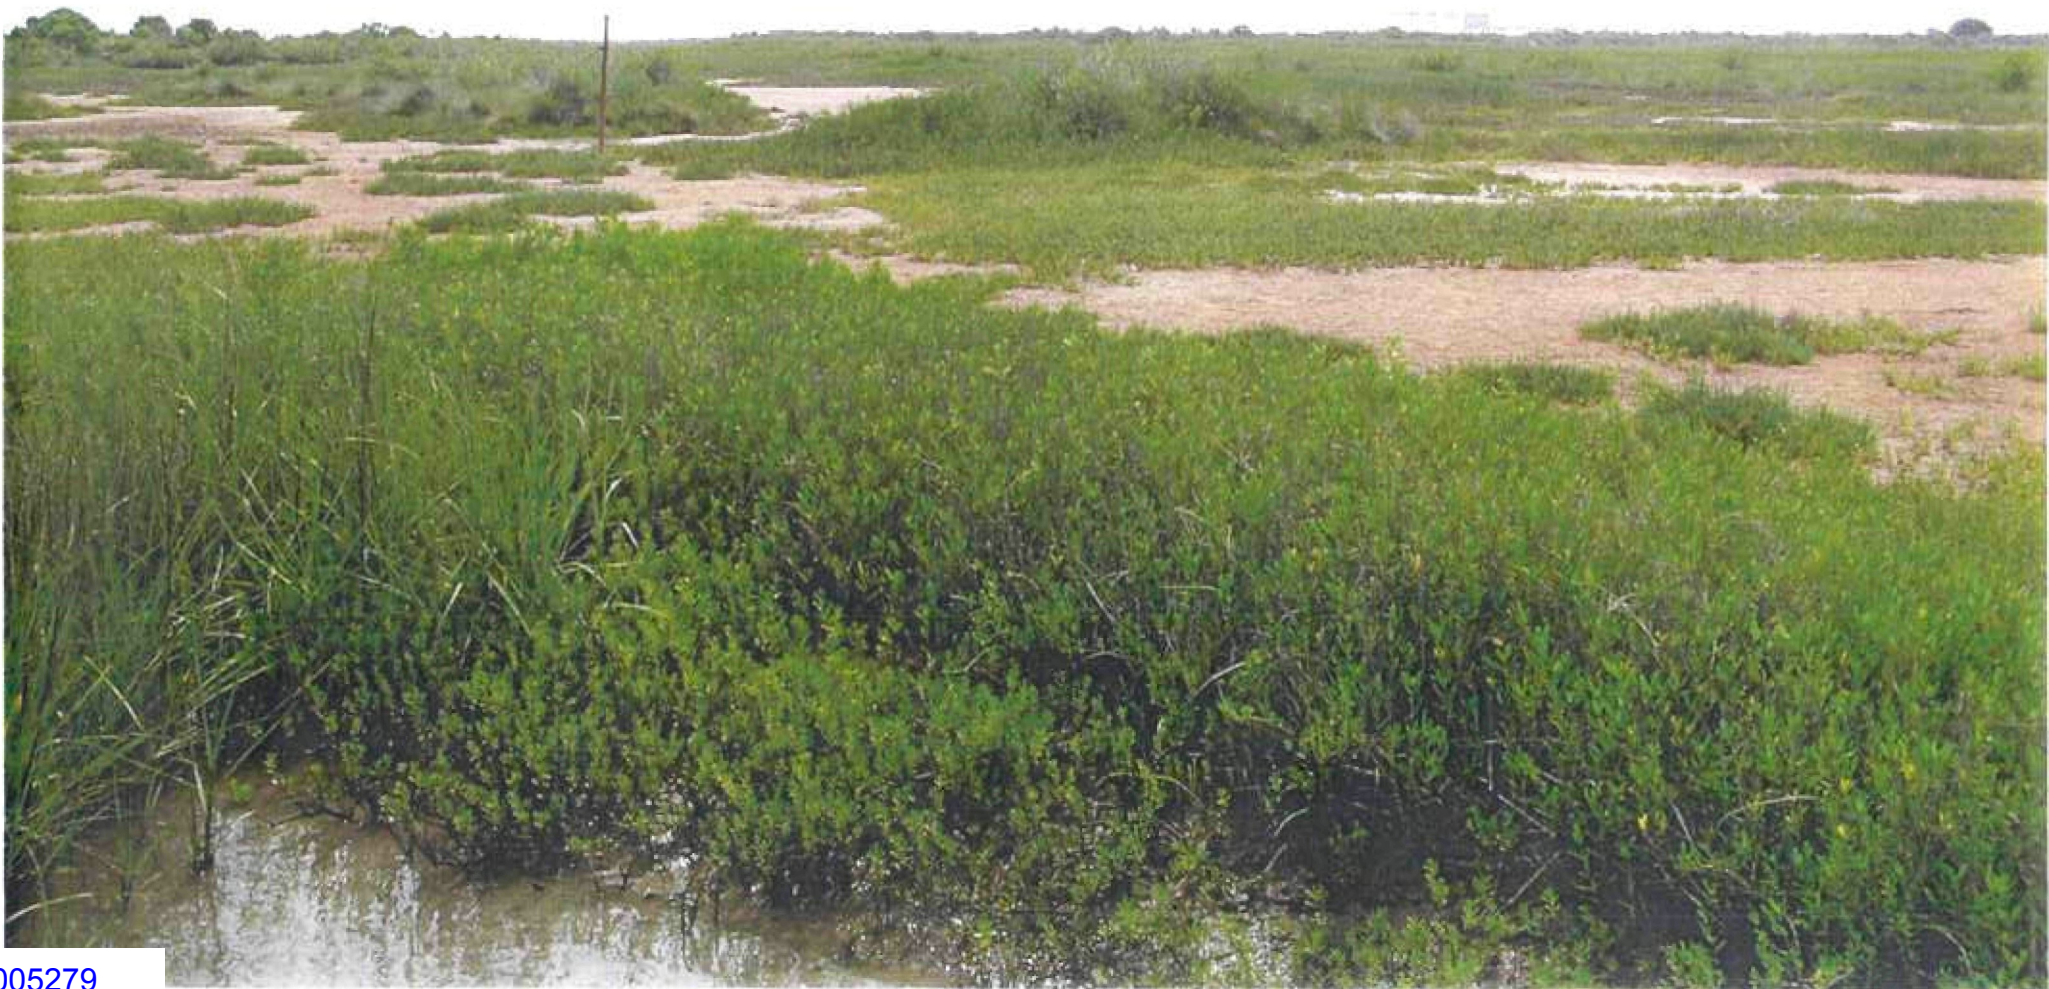
Table 1. Observations associated with Gulfco Marine Maintenance Site visit by USFWS personnel. Site numbers and lat./long. are associated with Figures 1 and 2.

Site Number	Lat./Long.	Comment
1	N 28° 58.464' W 095° 17.397'	Point approximately 40' inland from upland shoreline/fringe marsh within a man-made channel leading from extensive marsh situated between site and waterway occurring to the north (oxbow). This channel is a major drainage pathway (D/P) connecting site and adjacent marsh to oxbow leading to Freeport Channel.
2	N 28° 58.472' W 095° 17.407'	Point at immediate upland shoreline where above-mentioned channel enters into oxbow/fringe marsh.
3	N 28° 58.488' W 095° 17.371'	Second major D/P leading from extensive marshland situated between site and oxbow, and east of major D/P mentioned in #1. Point taken at metal post (reference point) located approximately 50' inland from adjacent shoreline.
4	N 28° 58.525' W 095° 17.327'	Point east of #3, representing easternmost side of abovementioned D/P.
5	N 28° 57.988' W 095° 17.256'	D/P on south shoreline of site leading from upland areas into Freeport Channel and located near concrete containment area.

6	N 28° 57.987' W 095° 17.249'	Second D/P on south shoreline slightly east of #5 where Portland cement dam was observed.
7	N 28° 58.008' W 095° 17.216'	Additional D/P on south shoreline near concrete slab.
8	N 28° 58.009' W 095° 17.205'	Additional D/P at west end of bulkhead facing Freeport Channel.
9	N 28° 58.041' W 095° 17.158'	D/P at culvert leading from southeast corner of site into Freeport Channel. Receives runoff from eastern portion of site.
10	N 28° 58.159' W 095° 17.342'	D/P from upland area (site tract located north of dividing paved road) into excavated pond near southeast corner.
11	N 28° 58.132' W 095° 17.359'	Southernmost PVC screen pipe occurring in suspected waste pit area immediately adjacent to excavated pond.

Site Number	Lat./Long.	Comment
12	N 28° 58.154' W 095° 17.375'	Northernmost PVC screen pipe at abovementioned area.
13	N 28° 58.170' W 095° 17.401'	Point at or near north property line where D/P connects suspected waste pit with extensive marshland occurring between site and oxbow to north.
14	N 28° 58.118' W 095° 17.459'	Point at estimated property line being northwest of ramp dry dock (on south side of dividing paved road) within D/P leading from site's north tract to extensive marshland situated north of site and dominant D/P from site to oxbow.
15	N 28° 58.040' W 095° 17.457'	D/P on west side of site (north tract) leading to offsite runoff area west of site.
16	N 28° 57.982' W 095° 17.416'	Road ditch at northwest corner of south tract adjacent to paved road dividing south tract from north tract.
17	N 28° 58.090' W 095° 17.290'	Culvert from road ditch leading to north tract under paved road.
